# Rack Safety: Why Is It Important?

## Risks of Ignoring Damage

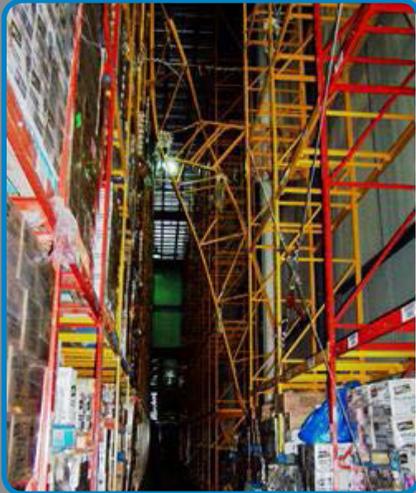
Rack damage was ignored

Examples of rack system collapses resulting from improper maintenance are shown below:

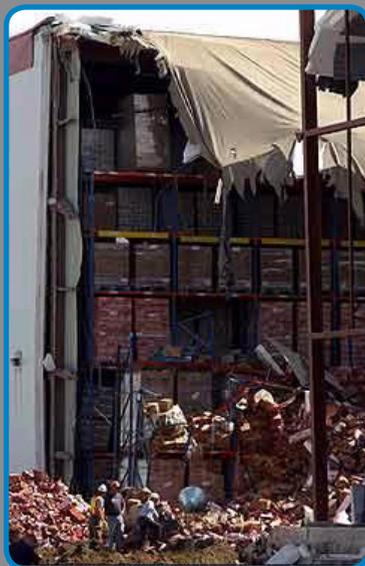
Rack collapse led to surrounding building's collapse

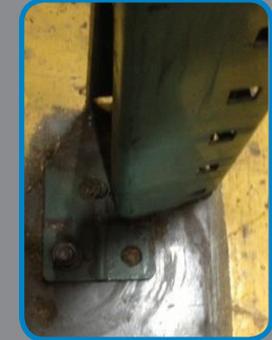
Sheared Anchor  
Footplate Separated From  
Column

In each of these examples, the damaged rack systems should be assessed and repaired or replaced, as directed by a qualified rack engineer.

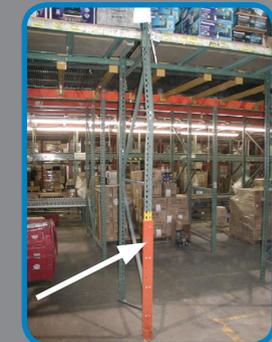
Damaged column with  
home-grown repair

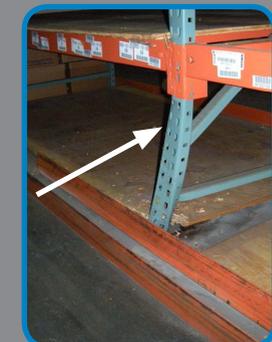
Damaged Upright

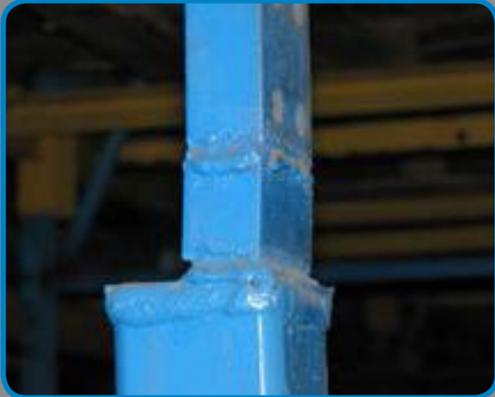
Unsafe Field Welding  
Repair

In these instances, the person who made the repair improvised, but a qualified engineer reviewing it recognized that the repairs had not been properly designed and had created a potentially unsafe condition. The improper repairs were removed and replaced with appropriate engineered solutions.

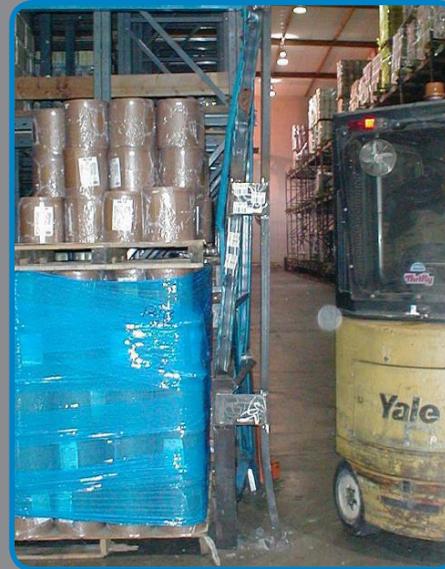
Unsafe Field Column  
Repair

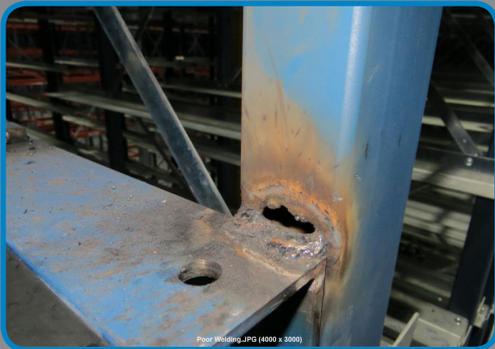
Defective Field Welding

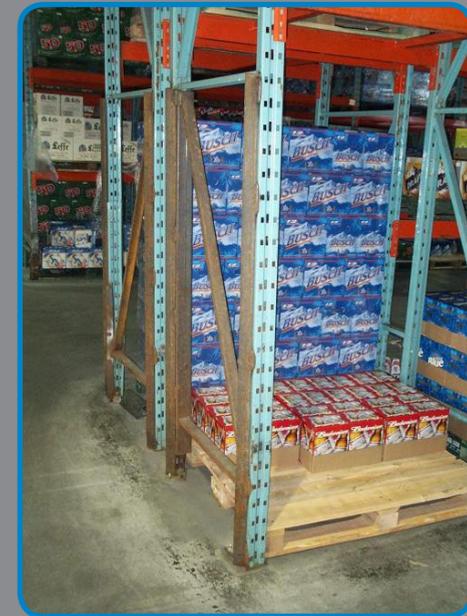
Unsafe Field Bracing  
Repair
